PAVEMENT FACILITY STUDY VERNON AIRPORT

Final Report

615404-30RF-0001-REV00

November 19, 2013

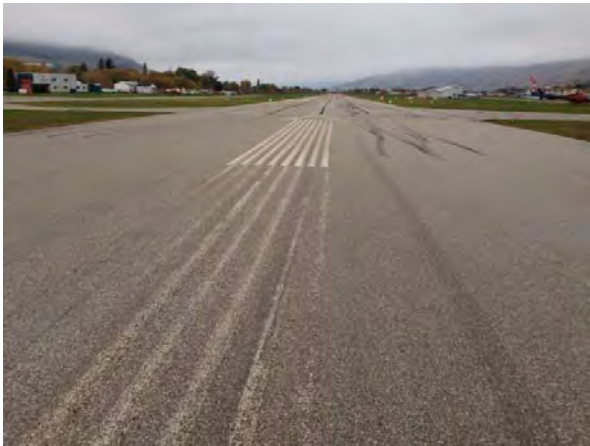
Constructed in 1998, this section is still in excellent condition. Very few distresses observed, only raveling (see picture No.2) of very low severity that may be attributed to a weak bonding between some of the larger aggregates and the bitumen. This section should be inspected regularly for loose particles (FOD) and broomed regularly.

Photo 4:1 - Section 1 overview

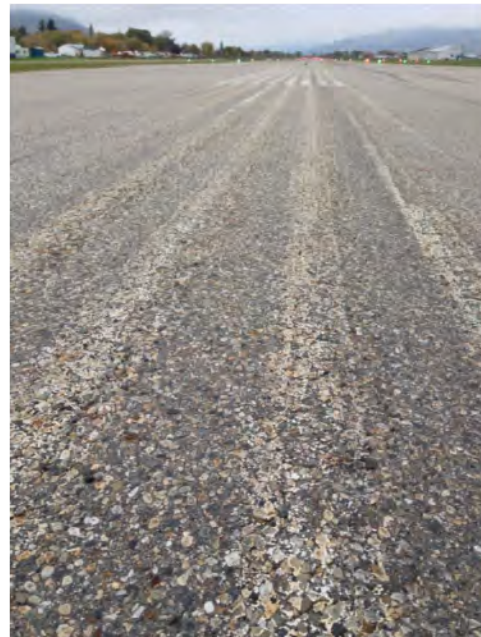
Photo 4:2 - Minor raveling in Section 1

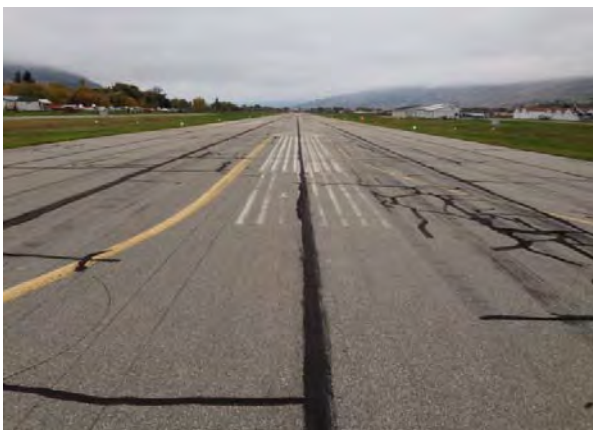
Photo 4:3 - Section 5 overview from Threshold 23

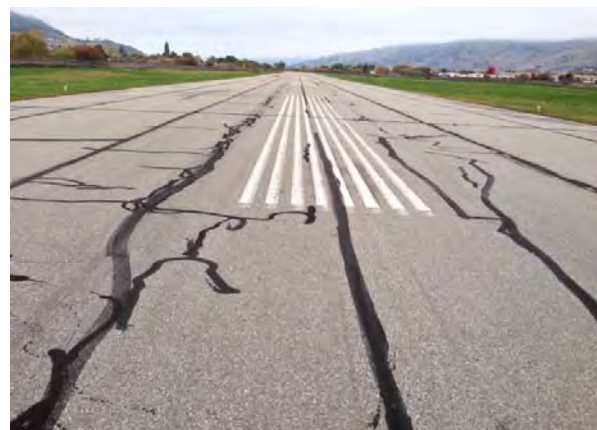
However, the extent of block cracking has now reached a high level which makes it unrealistic to properly maintain. The coverage of crack sealant in some areas reduces adherence and friction. Furthermore, the winter maintenance (snow plowing and brushing) tear the sealant and could generate FODs. It was observed that many cracks are opening faster than crack sealant can be reapplied, allowing water to penetrate under the asphalt layer and accelerating the degradation. This water which penetrates along cracks can cause serious damages in the winter when it freezes. Some of the cracks are severe and could also generate FODs.

Photo 4:4 - Extreme extent of block cracking

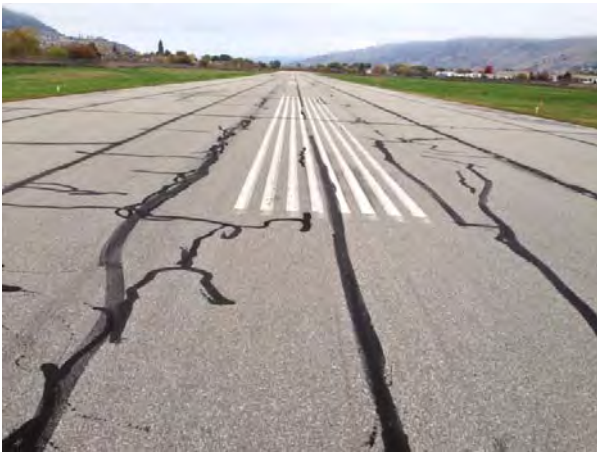
Photo 4:5 - Section 5 overview from Twy-D

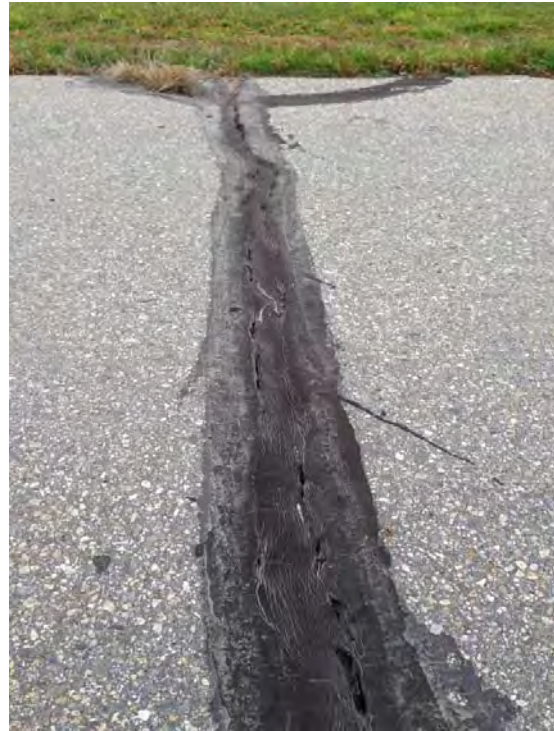
Photo 4:6 - High severity cracking

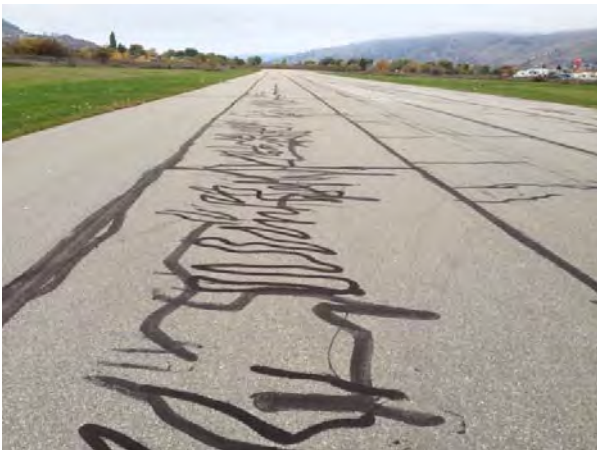
Photo 4:7 - Extensive crack sealing

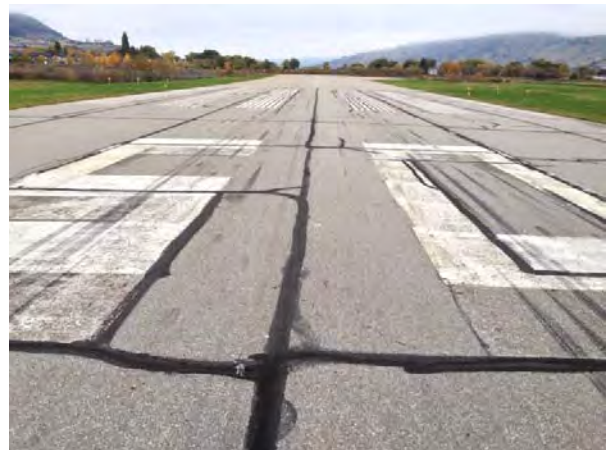
Photo 4:8 - Overview of threshold 05

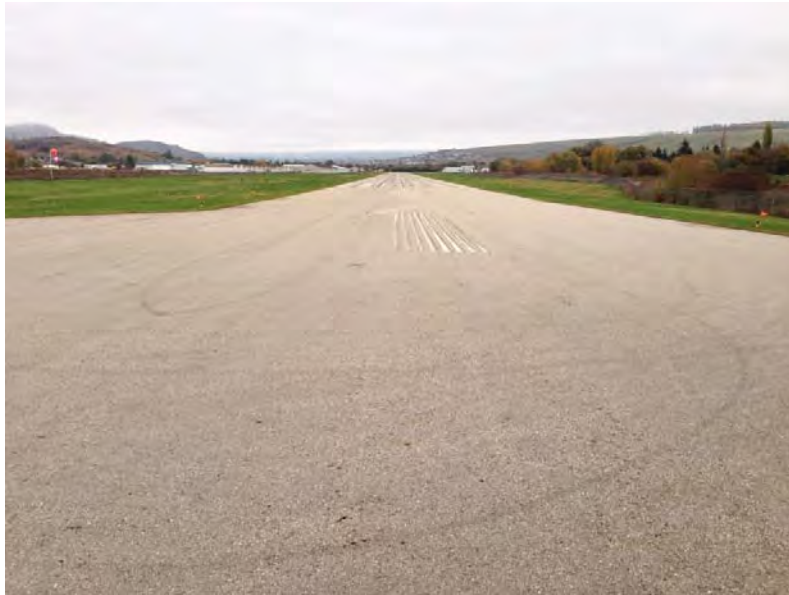
Constructed in 2006, this section is still in perfect condition; no distress observed in the entire section.

Photo 4:9 - Section 3 overview.

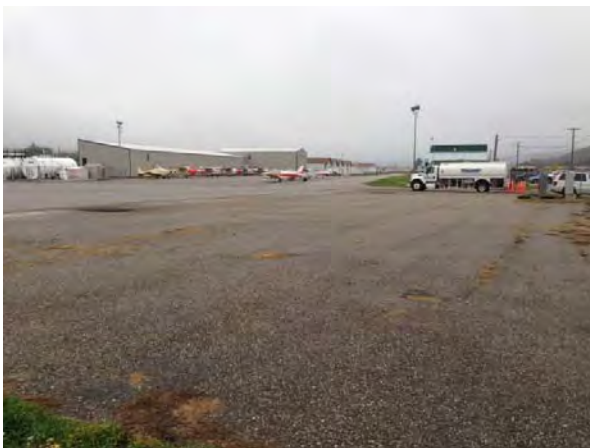
Apron #1 was originally paved in the 1960s and only a small area of this old pavement remains today. This sub-section 4A is in very bad condition; there is severe block cracking on 80% of the surface, the pavement is uneven with multiple depressions. This sub-section is prone to FODs and should be rehabilitated or condemned to aircraft traffic.

Photo 4:10 - Section 4A overview

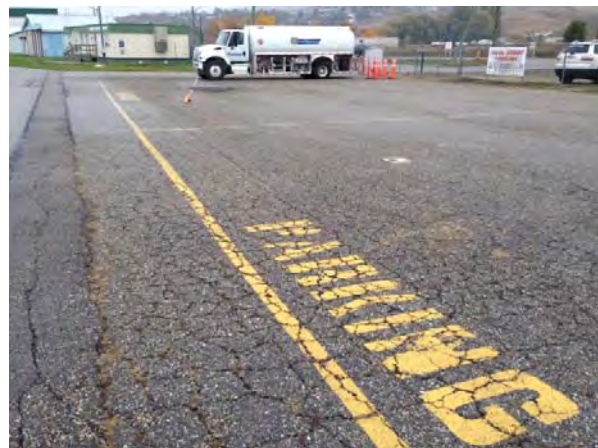
Photo 4:11 - Extreme Map Cracking in Section 4A

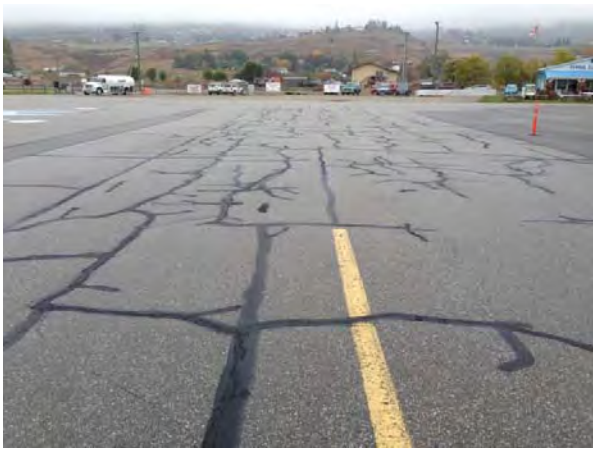
The sub-section 4E which corresponds to the extension of Taxiway Alpha dates from 1986 and is exhibiting extensive block cracking. The good maintenance that was done to seal those numerous cracks has prevented their degradation but the extent of those cracks would justify rehabilitation.

Photo 4:12 - Section 4E overview

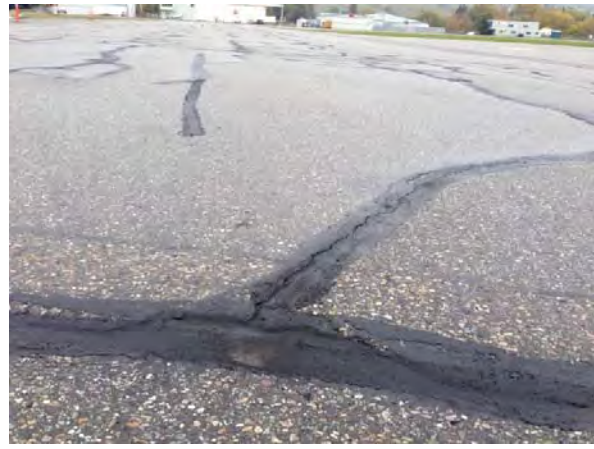
Photo 4:13 - High Severity Block Cracking in Section 4E

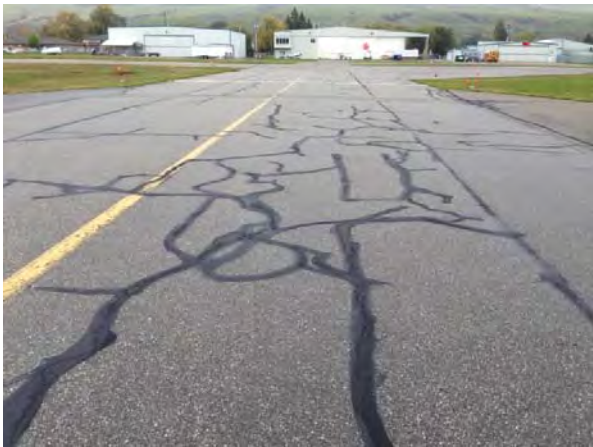
As mentioned before, Taxiway Alpha was constructed in 1986 and was never overlaid. Extensive block cracking is observed on this section but due to effective crack sealing, the cracks have not degraded. However, the extent of these cracks would justify rehabilitation.

Photo 4:14 - Section 5 overview

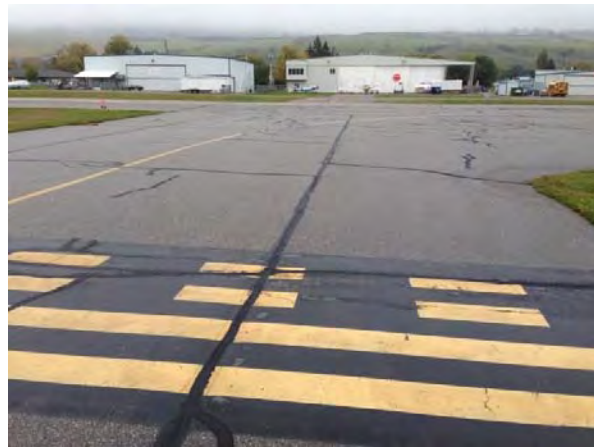
Photo 4:15 - Low Severity Cracking in Section 5

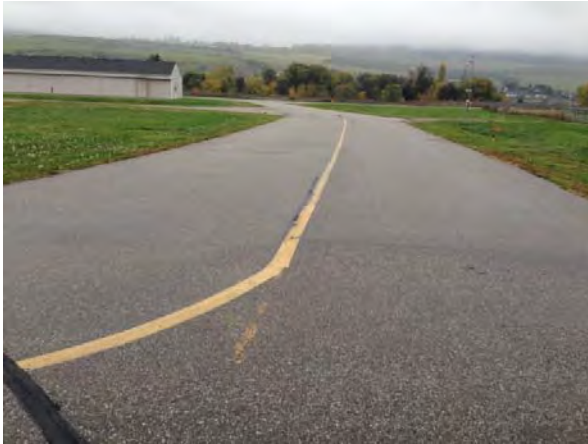
Taxiway Bravo was constructed in 1996 and is still in good condition. There are a few longitudinal and transverse cracks that have been properly sealed and one edge crack with grass in it but generally speaking, these defects do not pose a problem to the operations. This taxiway would not require rehabilitation before 8 to 10 years.

Photo 4:16 - Section 6 overview

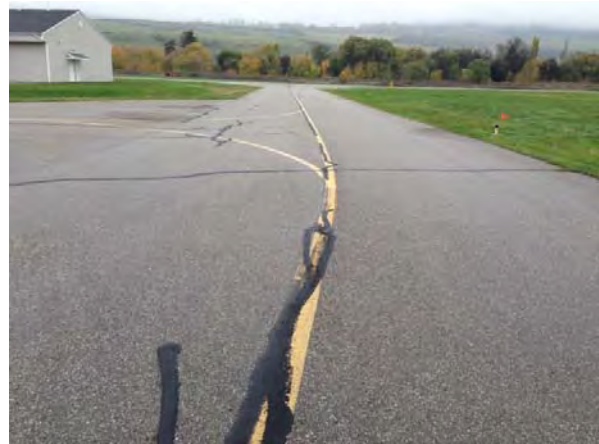
Photo 4:17 - Low Severity Cracking in Section 6

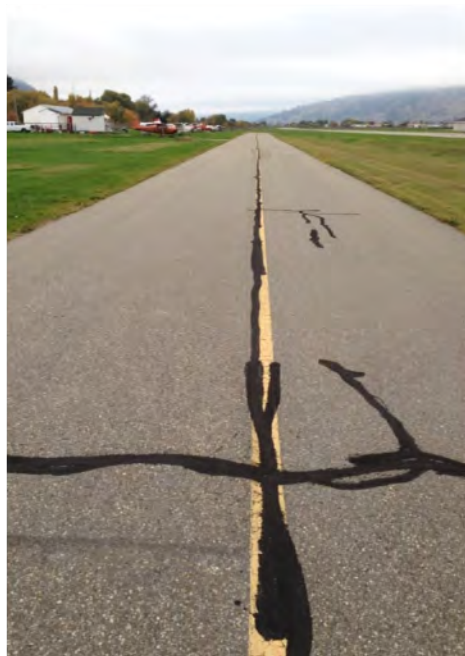
Taxiway Charlie was constructed in 1998 and has not been used much. Its condition is still excellent with very minor and scattered transverse cracks. The main distress that will require attention and maintenance is the center line crack that runs the entire length of the taxiway.

Photo 4:18 - Section 7 overview

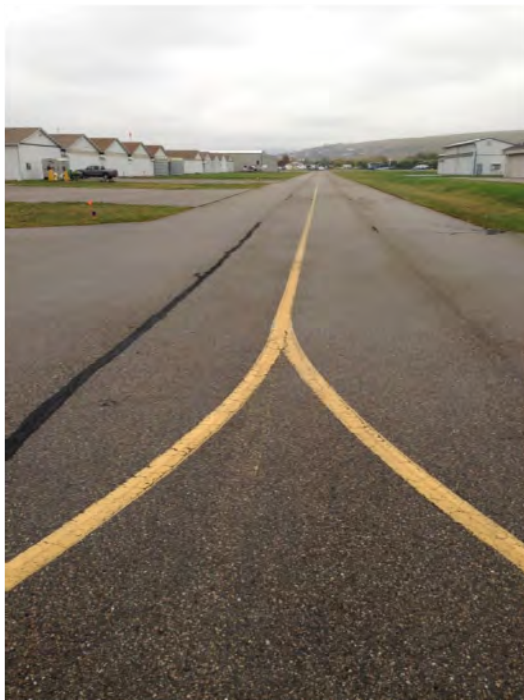
Taxiway Delta runs approximately where the old runway was located. However, in 2001, it was completely rebuilt under an ATAP grant. The only notable distress is a longitudinal crack that runs almost the entire length and is attributed to a cold joint during construction. The crack sealing will have to be maintained as is currently done to prevent degradation of the crack.

Photo 4:19 - Section 8 overview

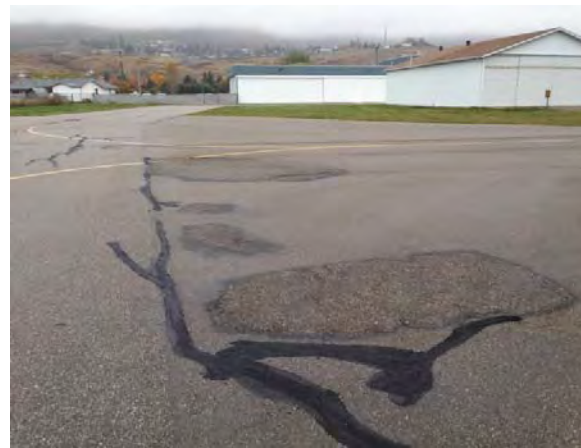
The intersection with Taxiway Bravo appears to have been problematic and there are old patches that may have been necessary to correct a water pounding problem. No action is necessary now but this problem should be addressed when the Taxiway is rehabilitated.

Photo 4:20 - Patches at intersection with Taxiway D

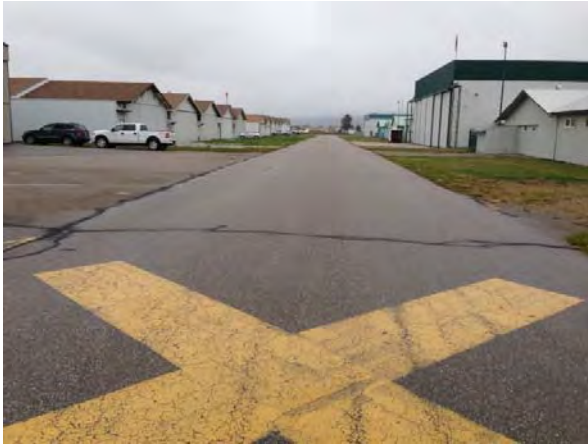
The old Taxiway was repaved in 1996 but its current width is not sufficient to be considered a Taxiway and this is why it is considered as part of Apron #2. Its current condition is excellent with very few transverse cracks widely spaced. Those cracks were properly sealed and will have to be maintained as such.

Photo 4:21 - Section 9 overview

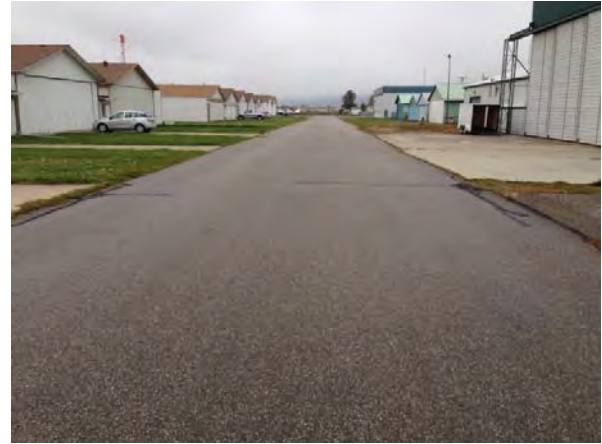
Photo 4:22 - Section 9 overview – cont'd

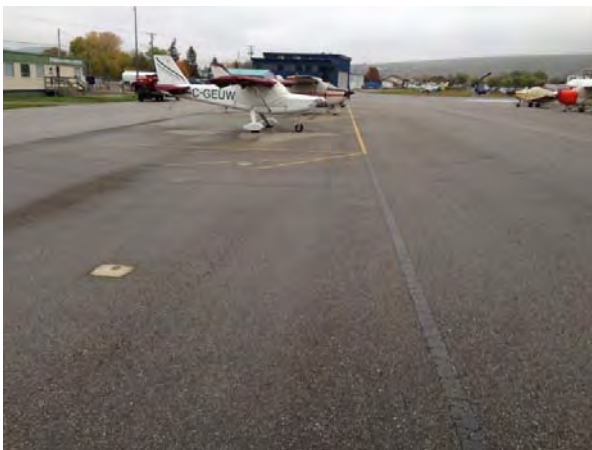
The main area of Apron #2 was built in 2005 to provide additional parking space for aircrafts. Its current condition is perfect with no visible defect.

Photo 4:23 - Section 10 overview

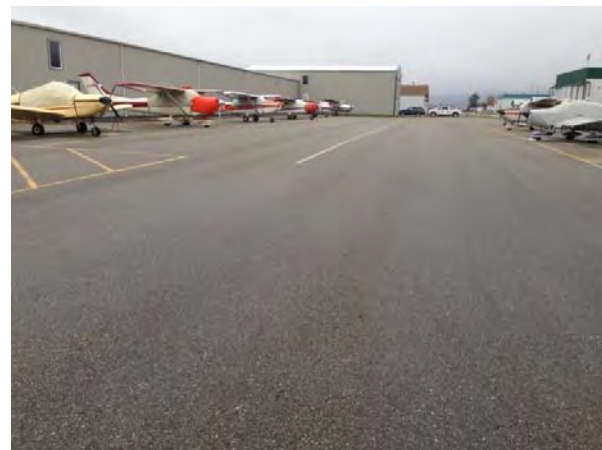
Photo 4:24 - Section 10 overview – cont'd

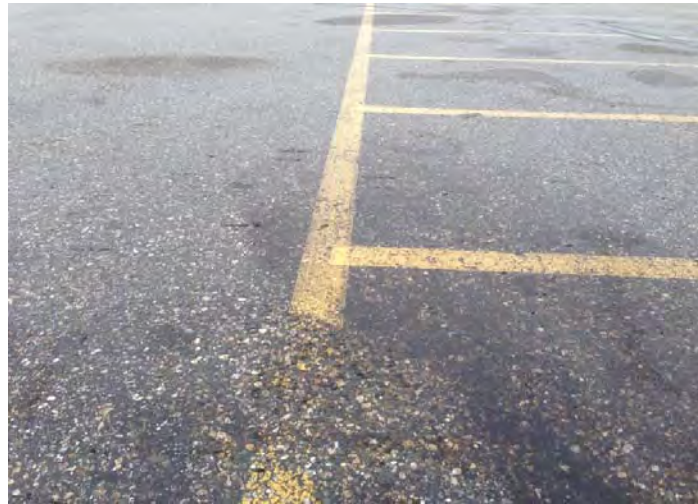
Apron #2 ties into Apron #1 near the fueling compound area. Several fuel spills have been observed on the pavement and it is noted that this could impair the durability of the asphalt binder. No visible degradation is observed at the moment but when rehabilitation will become necessary, building a concrete slab for the refueling area should be considered.

Photo 4:25 - Fuel spills near the fuel compound area in Apron #1

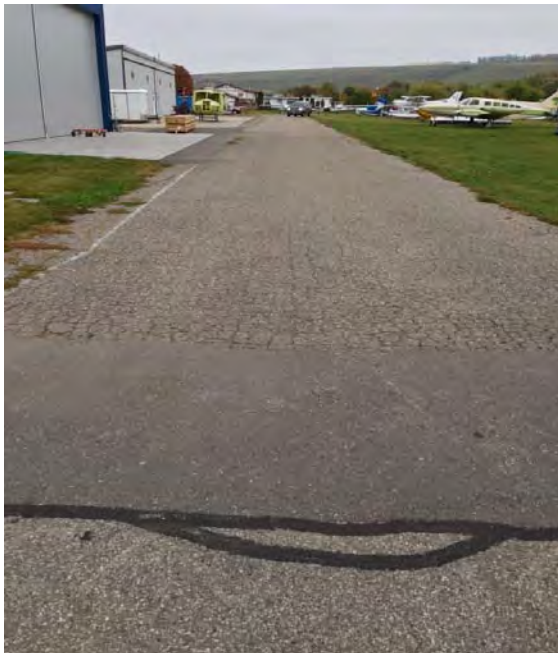
The service road dates back to the original construction in 1976 and has now reached its terminal condition and should be rehabilitated. However, no aircraft uses this road and very limited traffic. Depending on the decision to extend Apron #1 or not, a portion of this road could be integrated into Apron #1. The rest of the road could be left as is.

Photo 4:26 - Section 11 overview

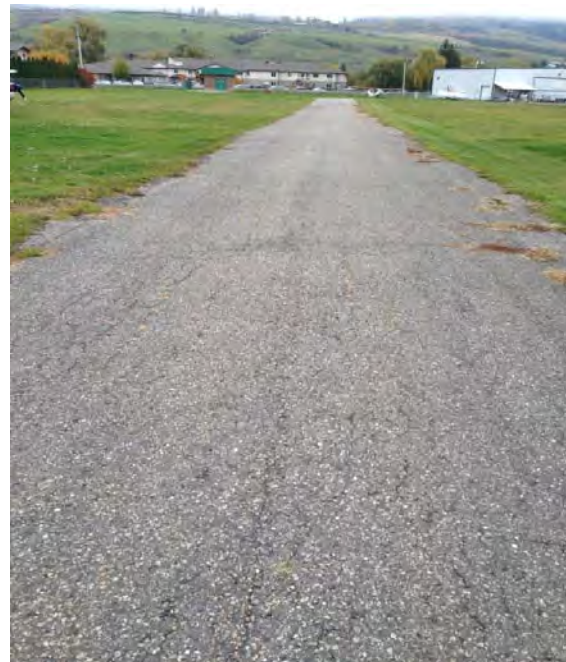
Photo 4:27 - Section 11 overview – cont'd
