Golder Associates Ltd.

July 8 2004

04-1440-145

**RE: GEOTECHNICAL ASSESSMENT FOR
SUBDIVISION DEVELOPMENT PLAN
EAST BELLA VISTA HIGHLANDS – TURTLE MOUNTAIN
VERNON, B.C.**

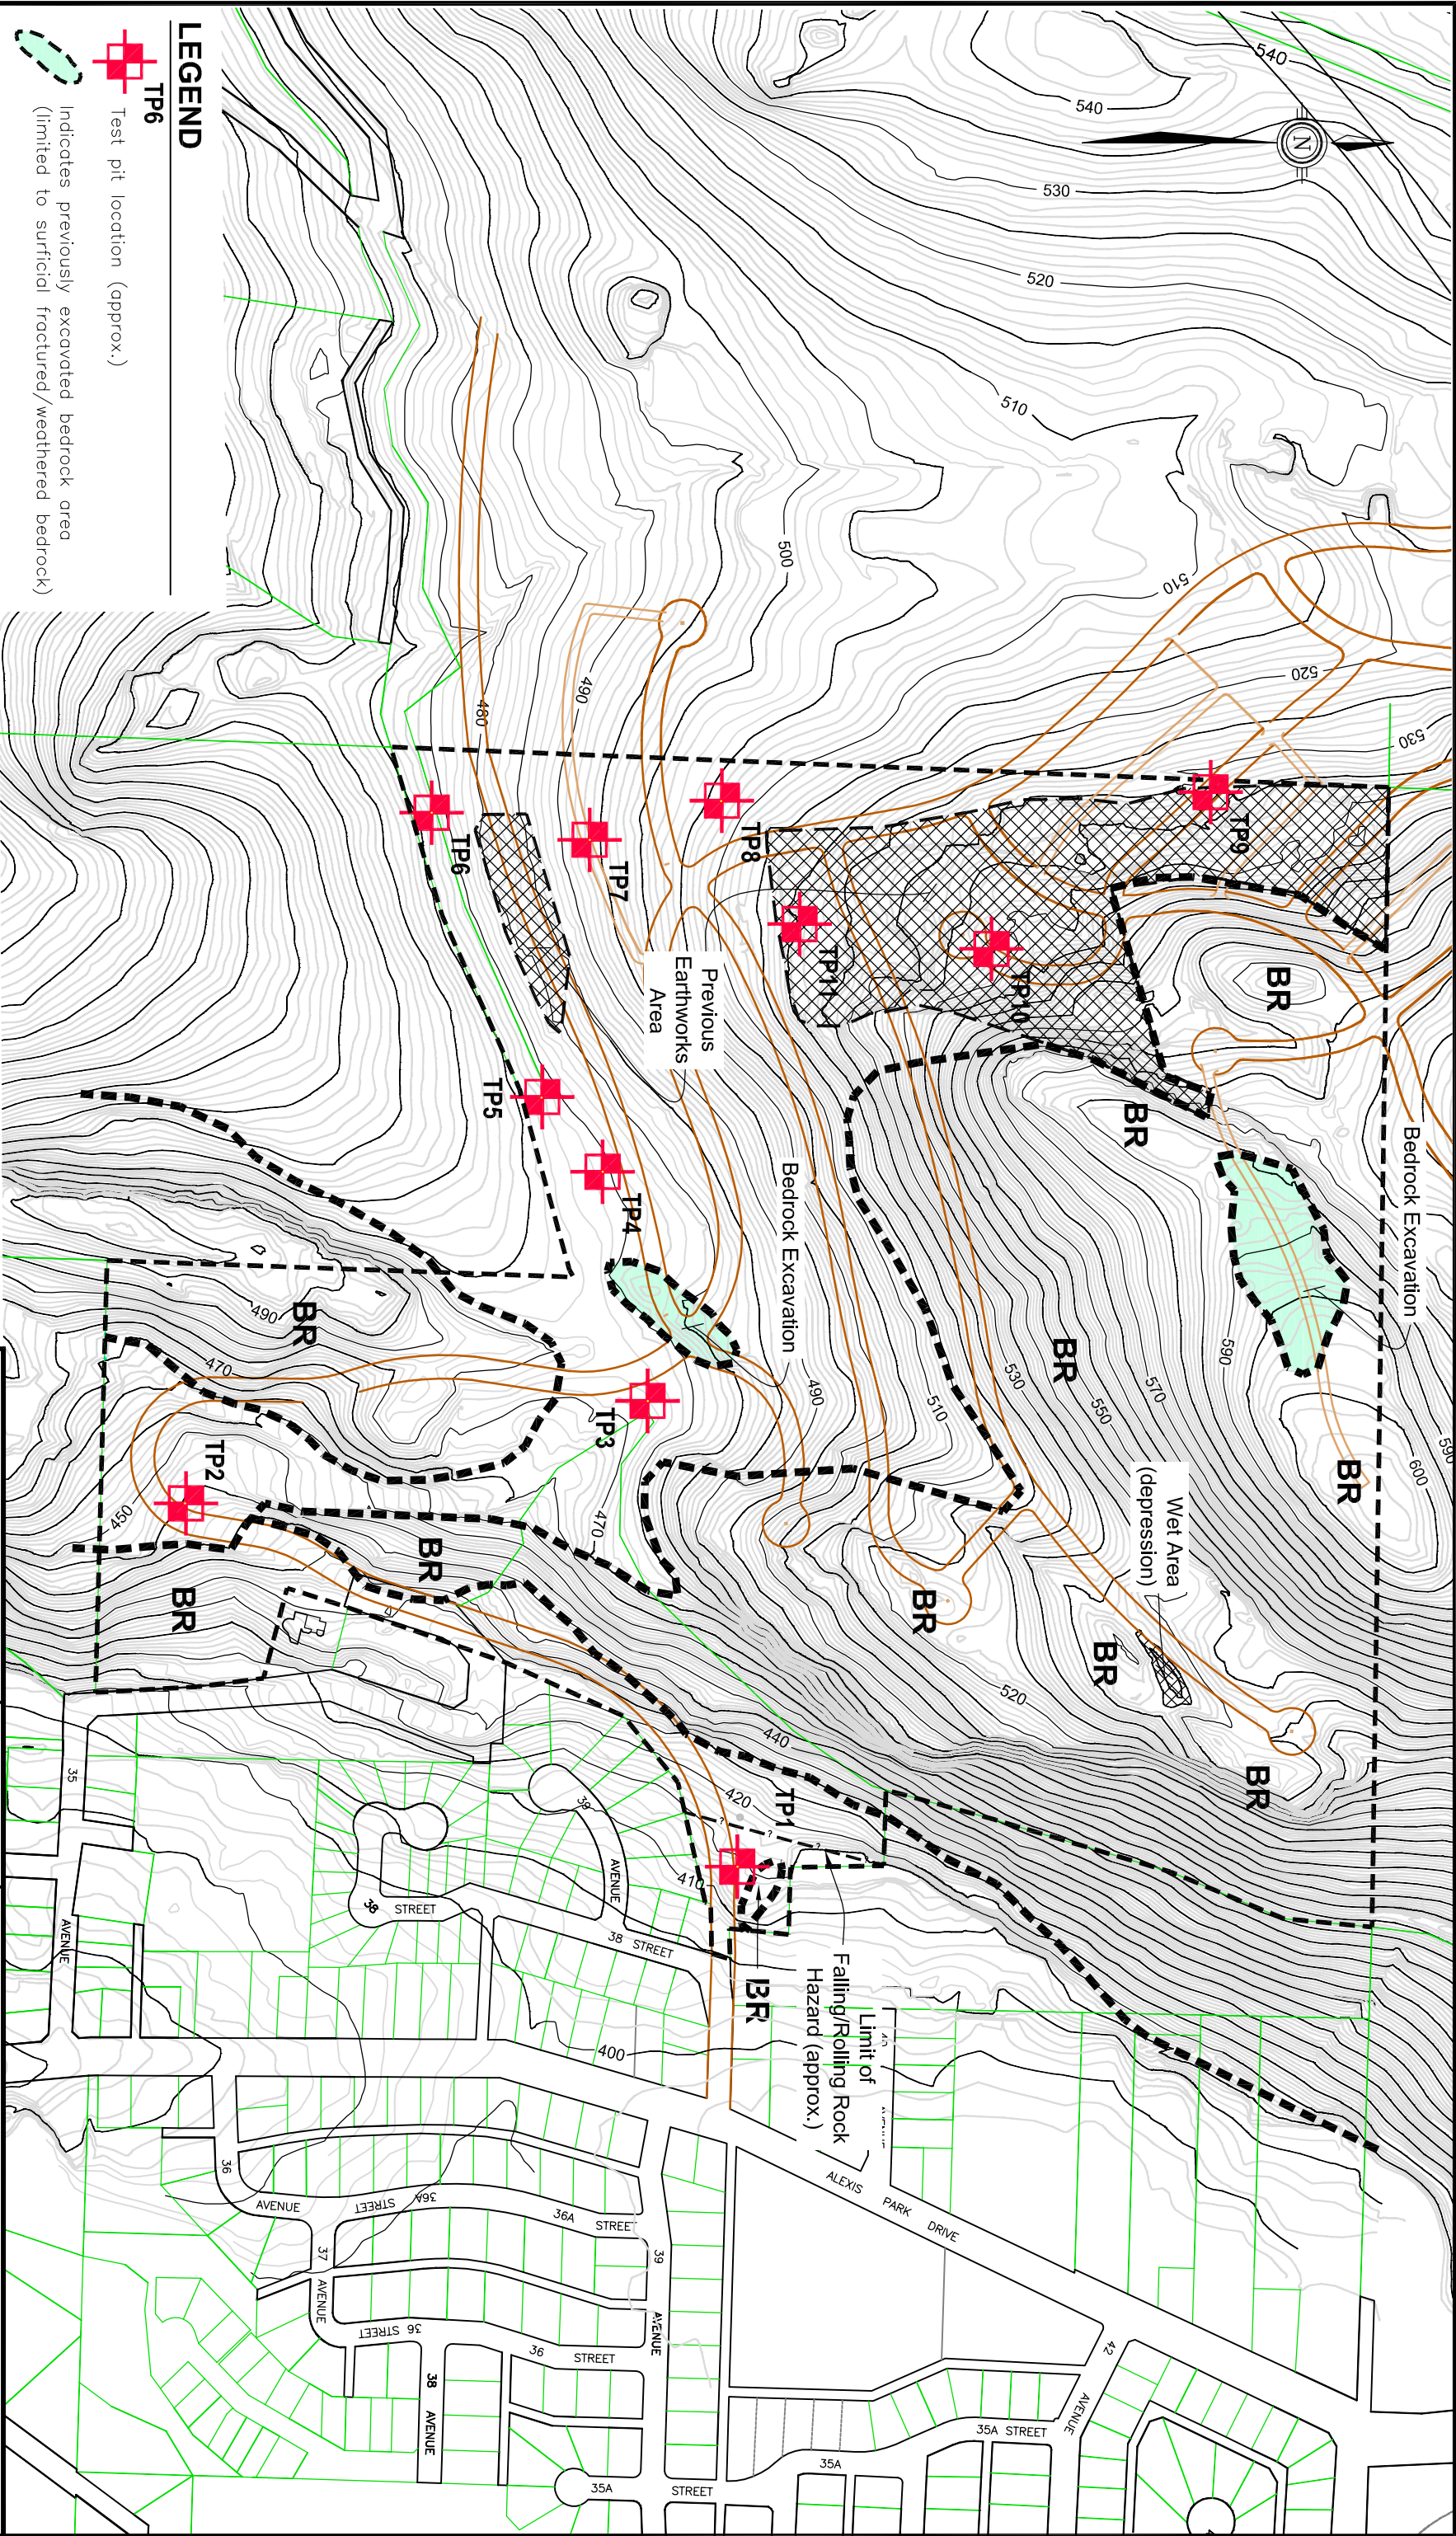
| | | | | 2 |

Figures 2 and 3 delineate the approximate areas of exposed and/or shallow bedrock together with areas where previous earthwork was undertaken. The area where exposed and/or shallow bedrock exists is generally limited to the higher elevations and along the steeper slope portions of the site. The bedrock exposed at surface is generally weathered and fractured. The weathered and fractured bedrock in the areas designated as “*bedrock excavation*” on Figures 2 and 3 has been subexcavated to a more competent bedrock surface. Observations also indicate some gravel extraction was carried out along the west

side of the bedrock ridge as shown on Figures 2 and 3. Extraction of gravel was terminated at the underlying dense gravelly silty sand deposit (till-like deposit).

A wet depression (old pond) area was noted between the two bedrock ridges, as shown on Figures 2 and 3. At the time of the reconnaissance, standing water was not observed, however, water reed growth with thick underbrush growth together with a large diameter willow tree were noted within the limits of this area. No evidence of groundwater seepage was noted along the base of the gully located down-gradient of the depression.

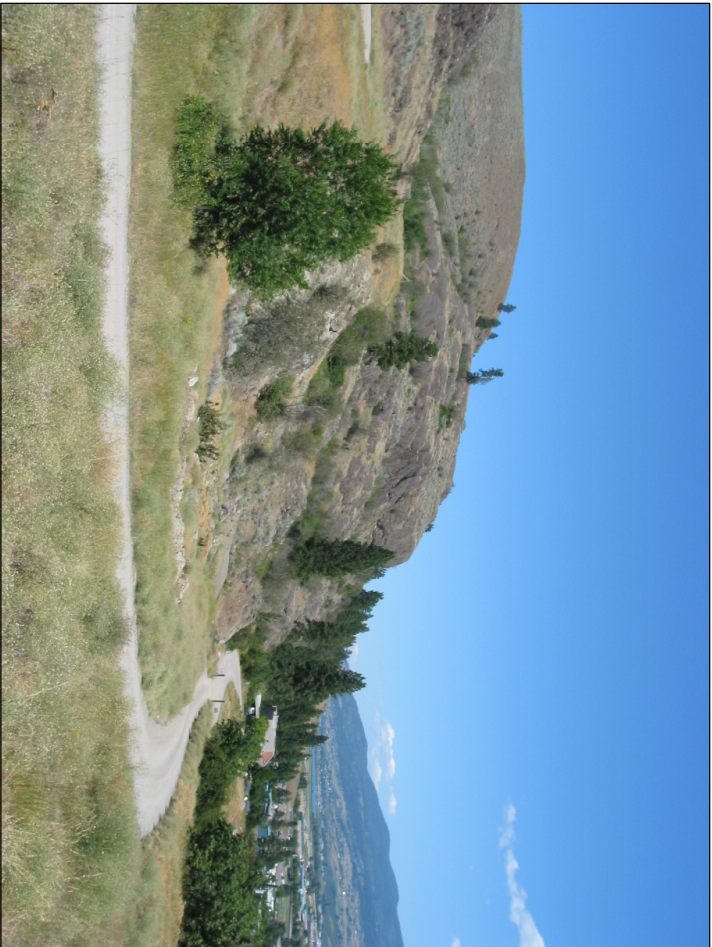
Further observations did not indicate any apparent evidence of slope instability and/or areas at risk from rockfall/rolling rock hazards, except for the area along the east toe of the steep slope at the west end of 39th Avenue in the vicinity of TP 1 where occasional angular rock fragments noted.

LOOKING NORTH FROM TEST PIT 2 AT STEEP BEDROCK FACE ALONG EAST SIDE OF THE STUDY AREA. OCCASIONAL SCATTERING OF OLD, ANGULAR FALLING ROCK FRAGMENTS ALONG THE TOE OF THE BEDROCK AND TALUS SLOPE.

Based on our observations of the extent of the rolling rock within the vicinity of TP 1, it is our opinion that proposed lots located downslope of the designated hazard line are not likely to be subject to a rockfall/rolling rock hazard from the relatively steep bedrock face that is located to the west. However, it is recommended that consideration be given to scaling the steep bedrock slopes west of TP1.

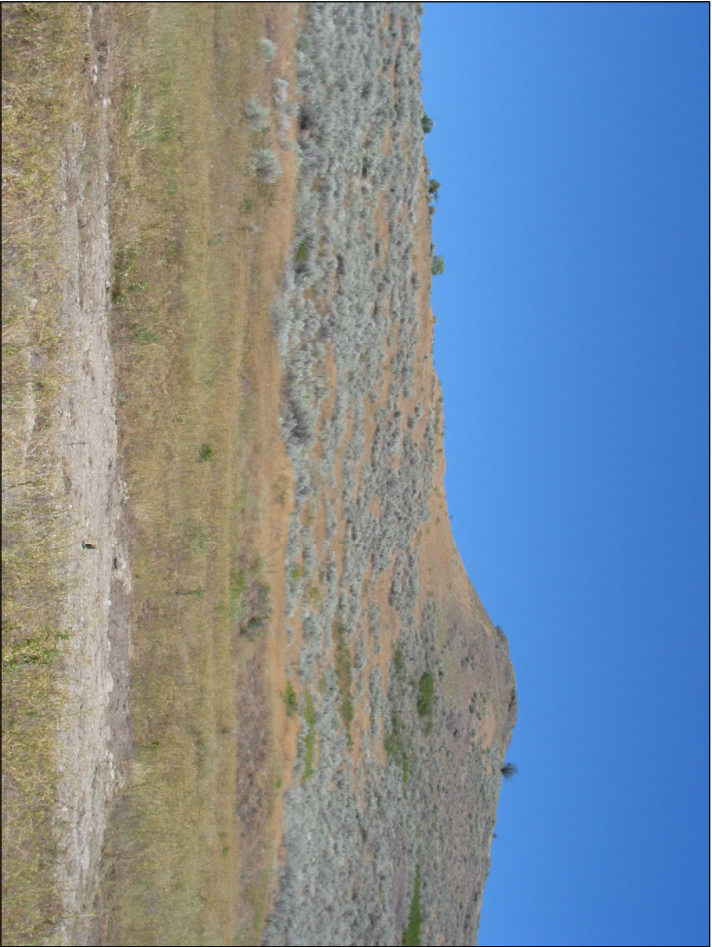
LOOKING NORTH FROM TEST PIT 4 AT BEDROCK RIDGE THAT EXTENDS TO AN ELEVATION OF ABOUT 590m. NOTE THE CHANGE IN GRASS COVER INDICATING APPROXIMATE SOIL/BEDROCK CONTACT.

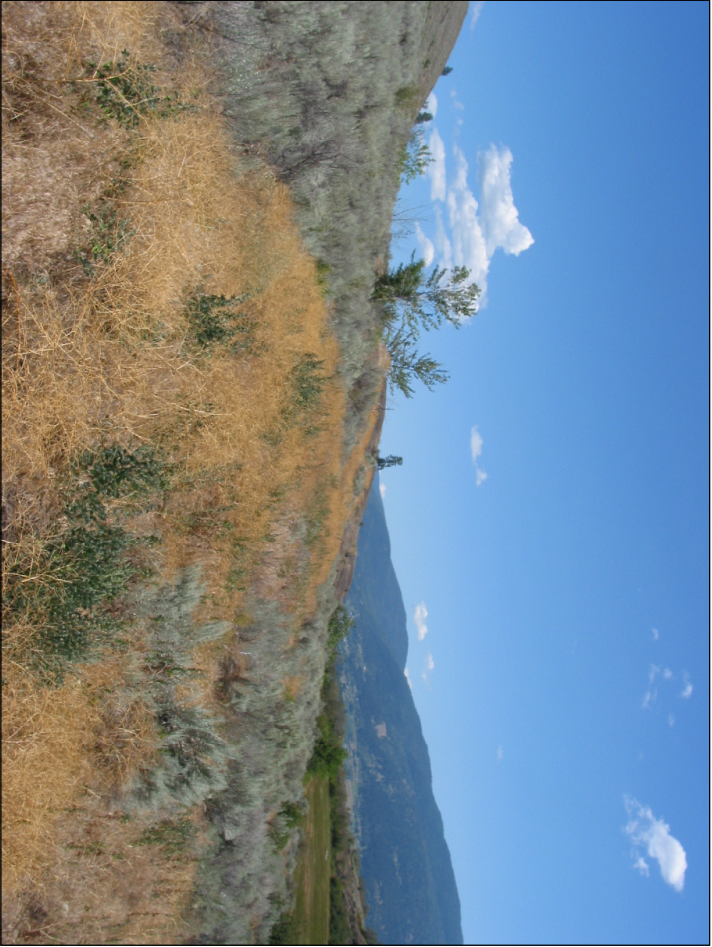
LOOKING NORTH EAST FROM TEST PIT 6 AT PREVIOUS EARTHWORKS AREA LOCATED NEAR THE SOUTH WEST CORNER OF THE STUDY AREA.

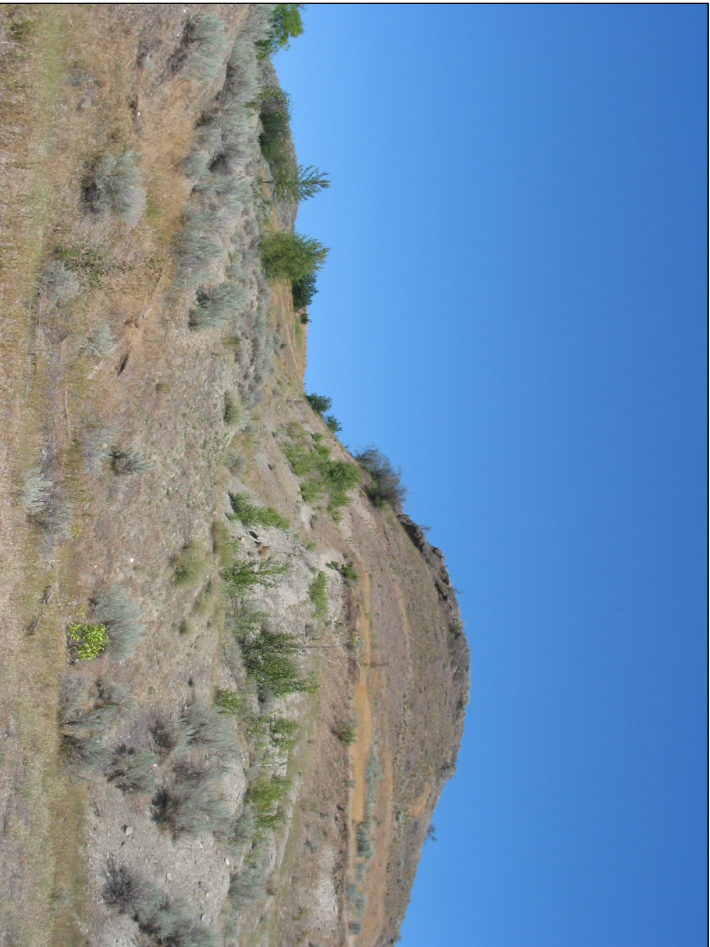
LOOKING NORTH EAST FROM TEST PIT 11 AT EXCAVATION SIDE SLOPE FROM PREVIOUS EXTRACTION OPERATION. EXPOSED SIDE SLOPE MATERIAL GENERALLY CONSISTS OF DENSE GREY SILTY SAND AND GRAVEL (TILL-LIKE) AT OVERALL SLOPE ANGLES OF ABOUT 50° TO 70°.

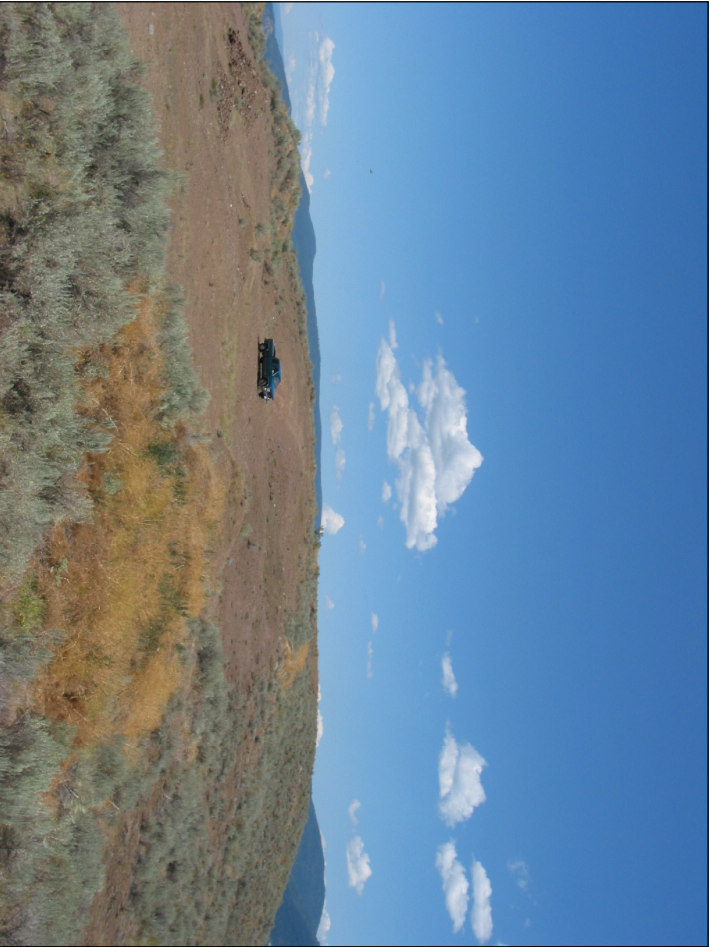
LOOKING NORTH EAST FROM TOP OF BEDROCK RIDGE SHOWING THE PREVIOUS STRIPPING OF THE UPPER FRACTURED/WEATHERED BEDROCK SURFACE.

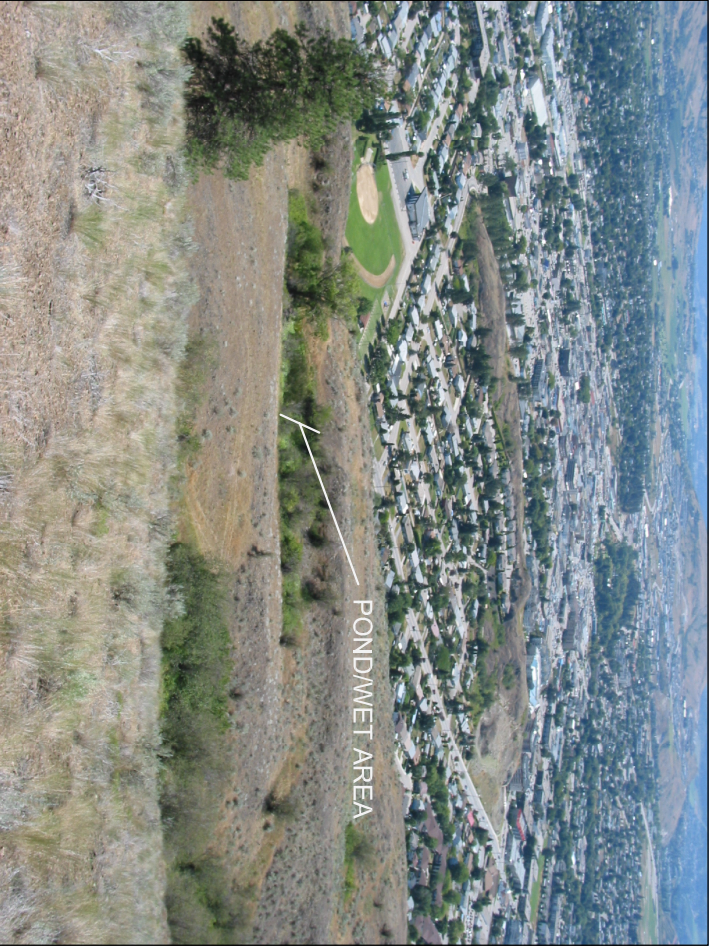
LOOKING EAST, SOUTH EAST ONTO EXISTING WET AREA/DEPRESSION WHERE REED GROWTH AND LARGE WILLOW TREE AND UNDERBRUSH EXISTS.
