Runway Feasibility Report At Vernon Regional Airport

RUNWAY FEASIBILITY REPORT AT VERNON REGIONAL AIRPORT

City of Vernon

JUNE 2014 ISSUED FOR USE FILE: C31103234-01

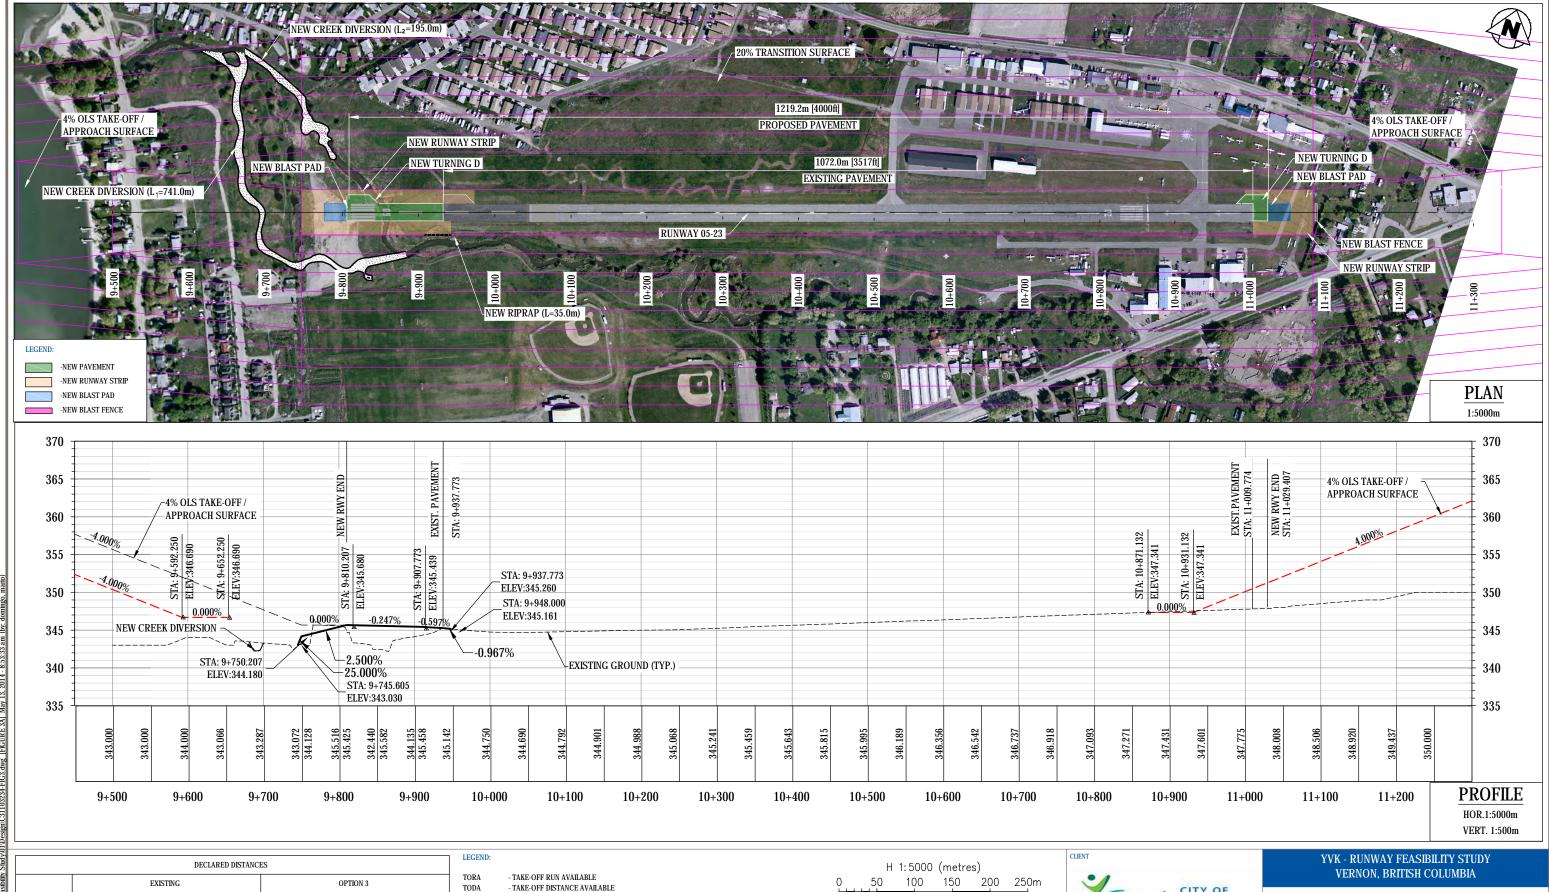
Figure 3A

DECLARED DISTANCES					
	EXIST	ΓING	OPTION 3		
	RWY 05 RWY 23		RWY 05	RWY 23	
TORA	1072.0m [3517ft]	1072.0m [3517ft]	1219.2m [4000ft]	1219.2m [4000ft]	
TODA	1072.0m [3517ft]	1072.0m [3517ft]	1219.2m [4000ft]	1219.2m [4000ft]	
ASDA	1072.0m [3517ft]	1072.0m [3517ft]	1219.2m [4000ft]	1219.2m [4000ft]	
LDA	961.0m [3154ft]	933.3m [3062ft]	1219.2m [4000ft]	1060.9m [3481ft]

TAKE-OFF DISTANCE AVAILABLE

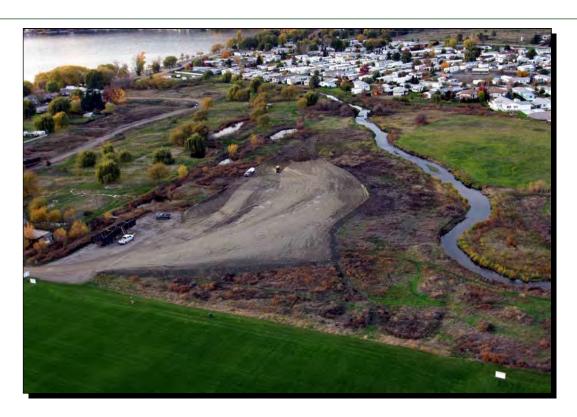
Photo 1 End of proposed runway with Marshall Fields in foreground - note wetlands (August 2006)

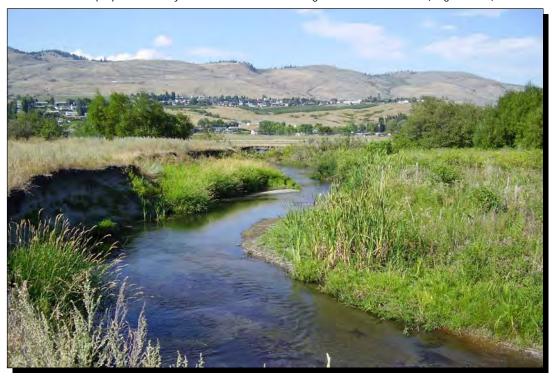
Photo 2
Typical flood bench on right side of photo (August 2006)

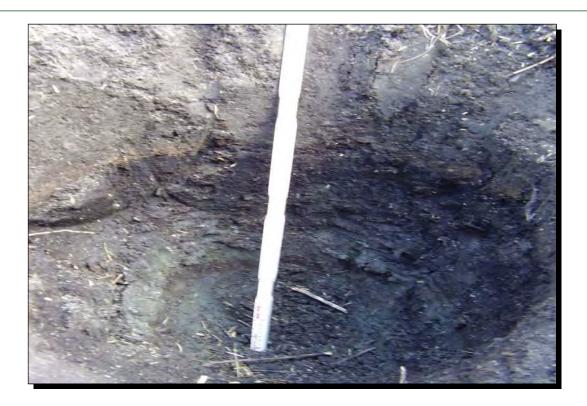
Photo 5 Soil pit at Marshall Fields (August 2006)

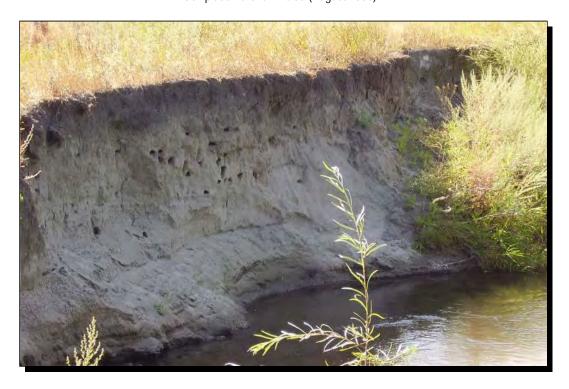
Photo 6
Swallow nesting cavities in stream bank at upstream end of study area (August 2006)

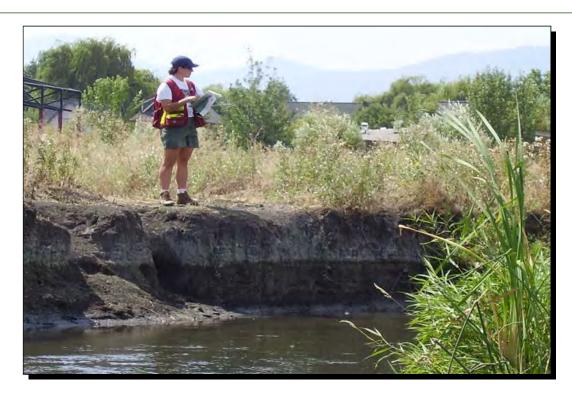
Photo 11 Vertical silt banks and evidence of sloughing near golf course (August 2006)

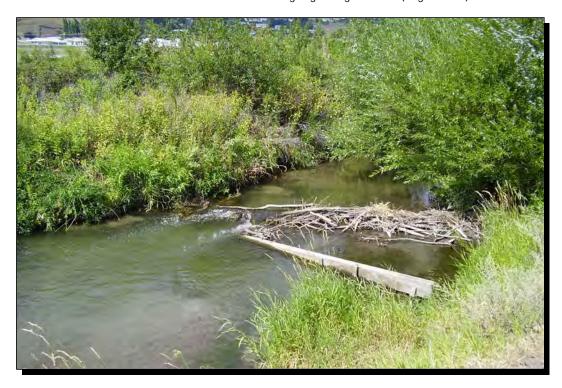
Photo 12 Wood weir and beaver activity (August 2006)

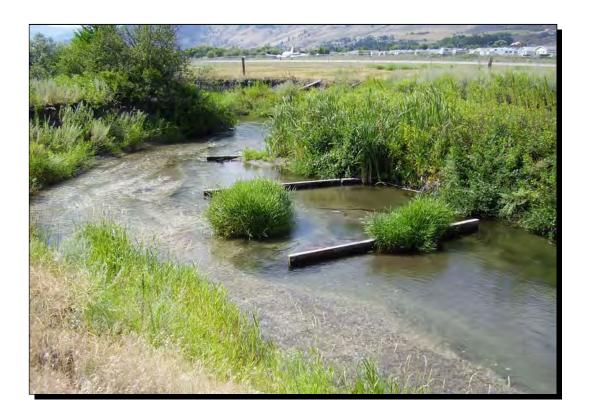
Photo 13 Wood weirs in Vernon Creek (August 2006)

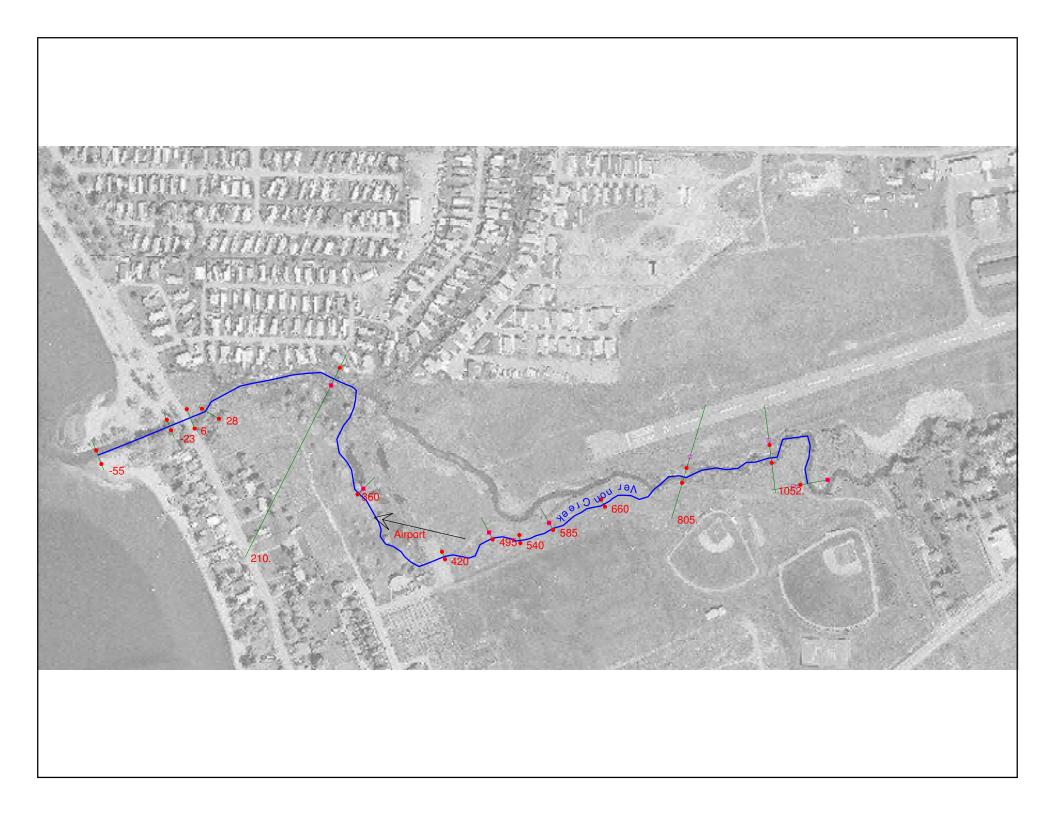
HEC-RAS Plan: Prop NoCulv River: Vernon Creek Reach: Airport
